**Prepared for the City of Littleton
Office of Community Development**

Diane Wray Tomasso
Historic Preservation Consultant
2905 South Elati Street
Englewood, Colorado 80110
303-552-8254
dwtomasso@gmail.com

PROPOSED NATIONAL REGISTER HISTORIC DISTRICT / ARAPAHO HILLS

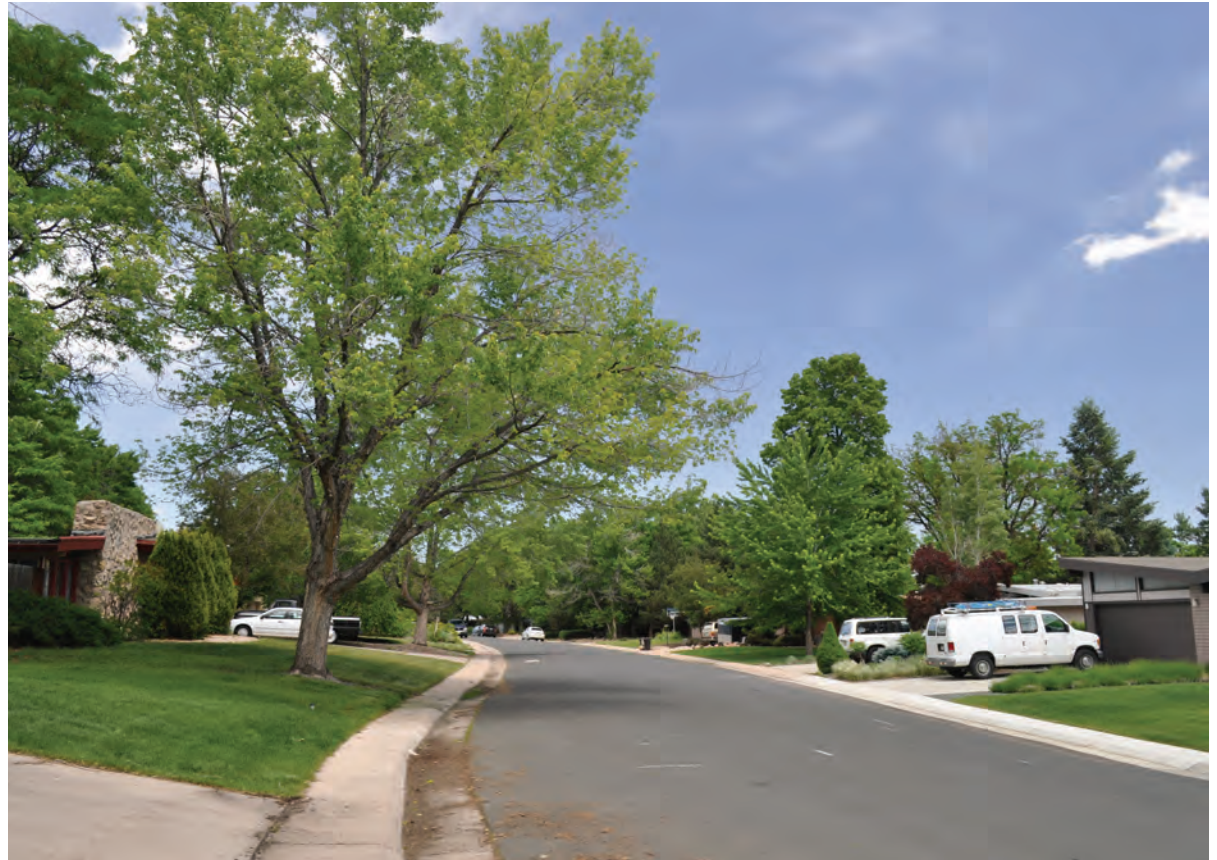
The Day House is centered on Chimayo where it intersects with the north end of Mohawk.

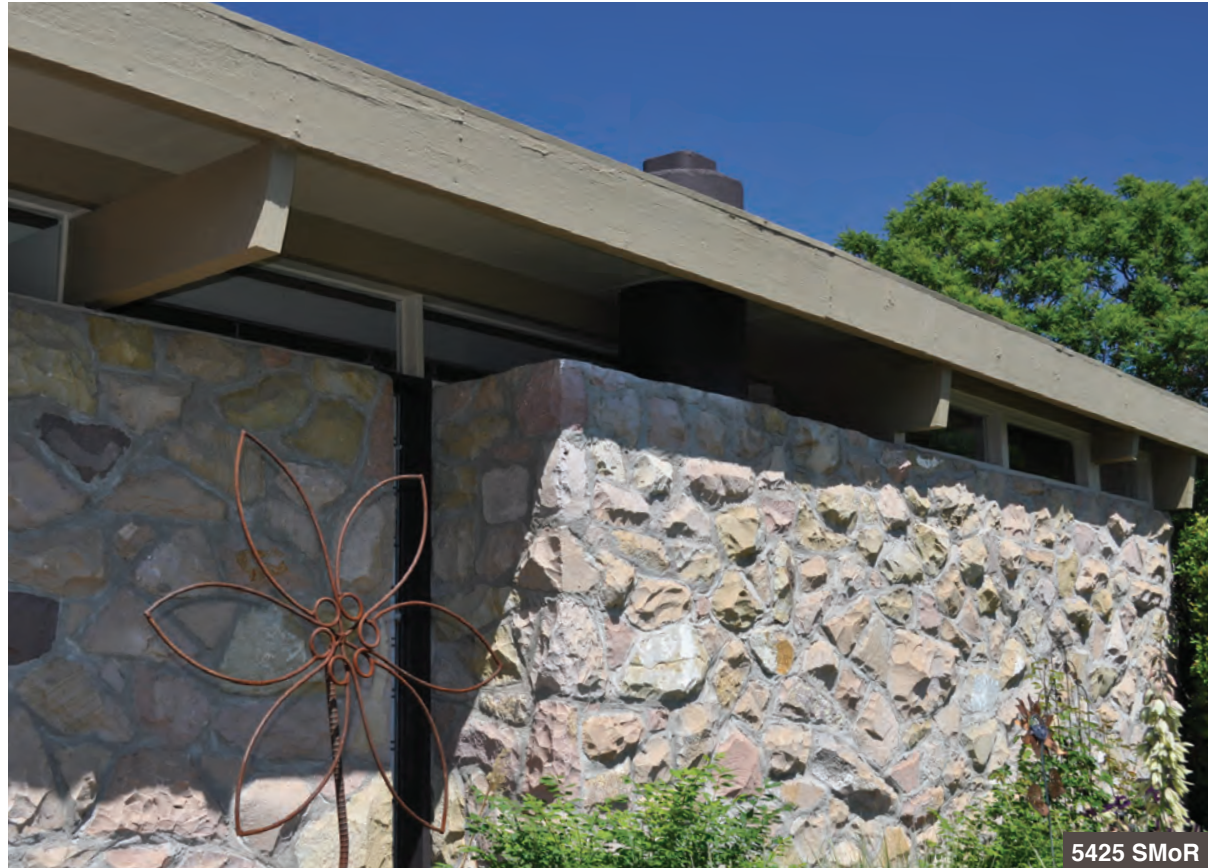
Casement sash are hinged on the left or right and swing outward. They are opened and closed by cranking a metal handle located on the interior frame. A metal latch operates the window lock. They have detachable window screens that install on the inside of the frame.

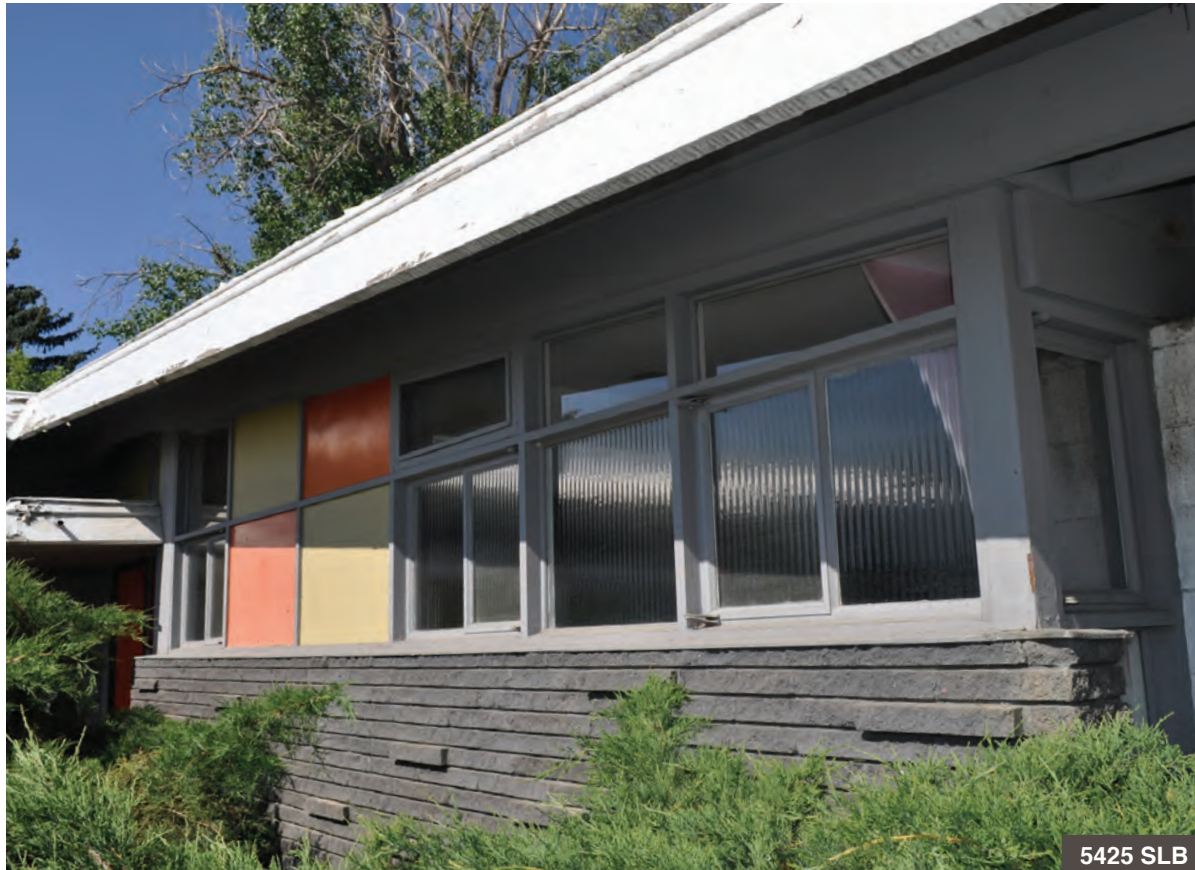
Vent or hopper sash are hinged at the bottom and swing inward. They are commonly wood with simple metal latches. Chains control the angle of the open sash. They have exterior screens.

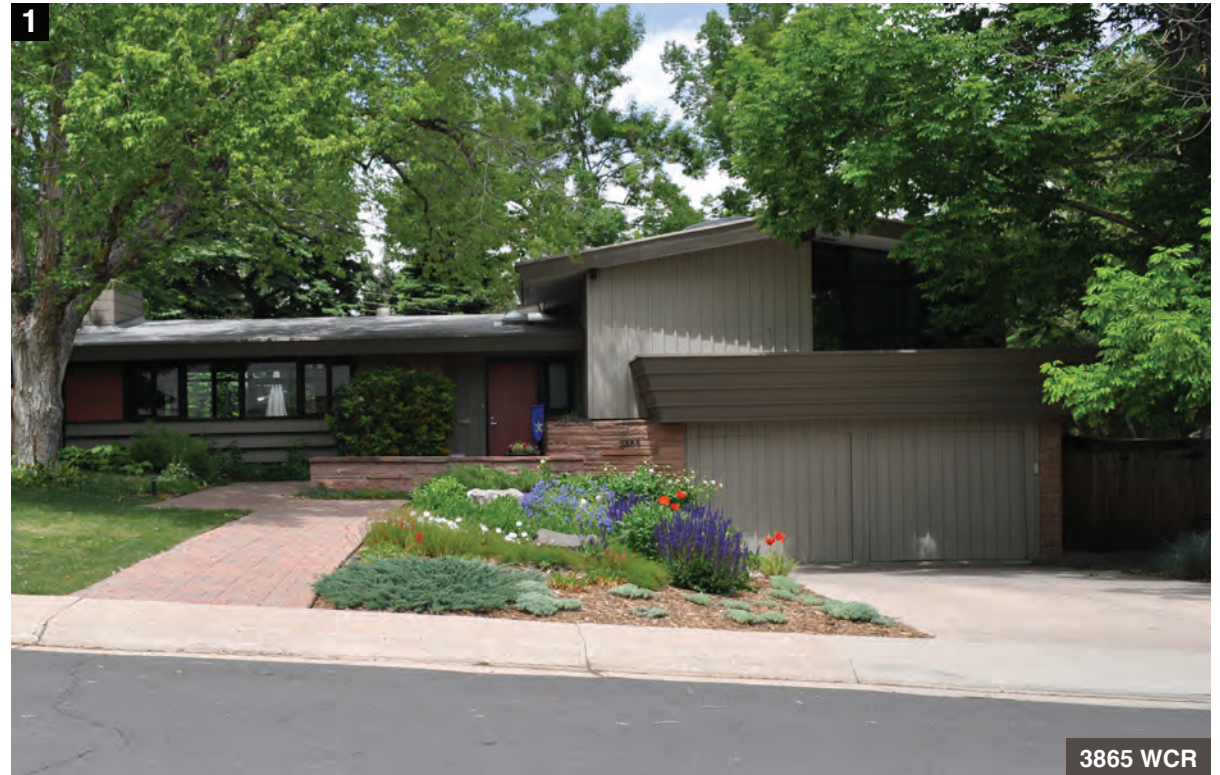
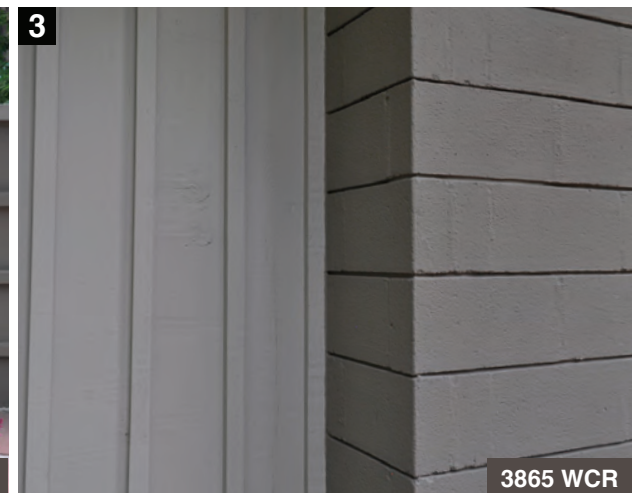
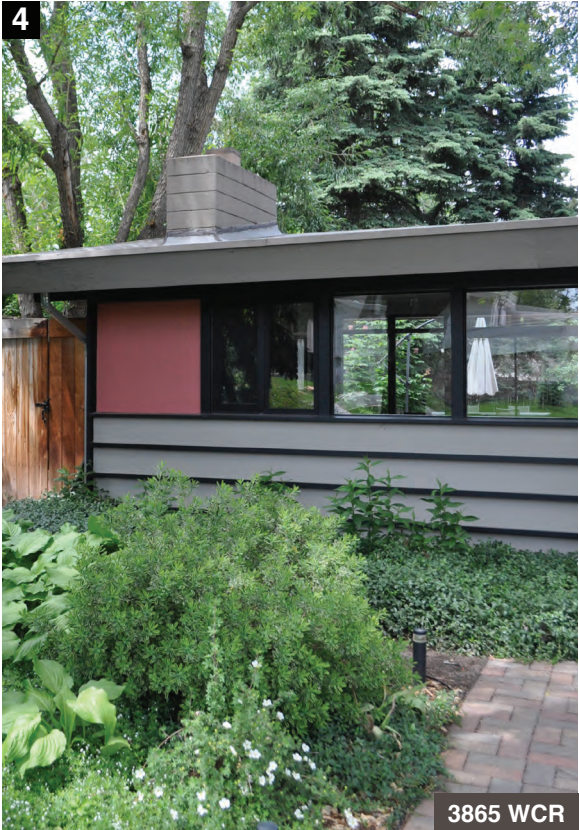
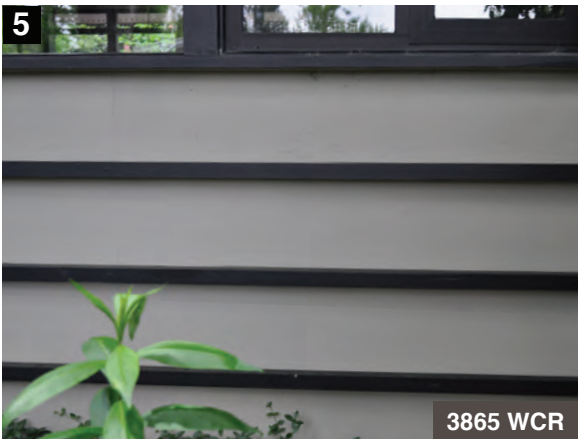
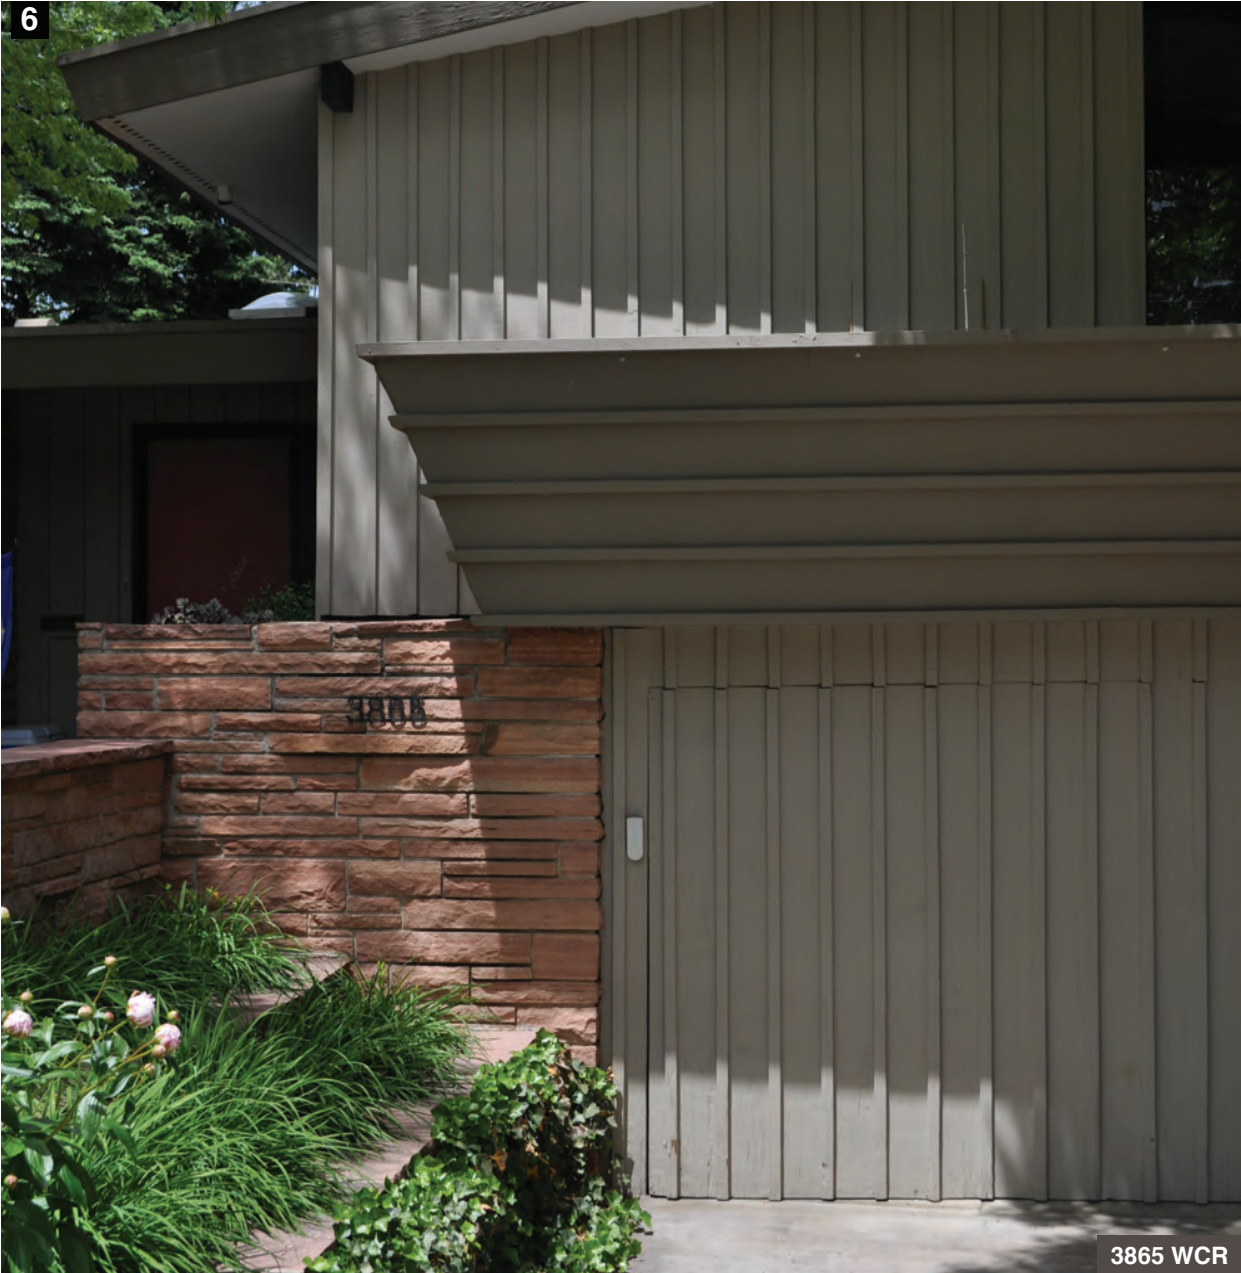
- 1 A view of the south elevation of the house.
- 2 Vertical and horizontal board-and-batten siding appears adjacent to a red sandstone patio.
- 3 Vertical siding joins a concrete block masonry wall with flush vertical and deeply raked horizontal mortar joints.
- 4 The varied materials are unified by their color palette and horizontal lines.
- 5 The boards and battens of the horizontal wood siding are painted a single color on the balcony fascia and contrasting colors on the wall adjacent to the entrance. This siding replaced the red sandstone originally shown on the drawings.
- 6 The proportions of the boards and battens vary between the vertical and horizontal siding.

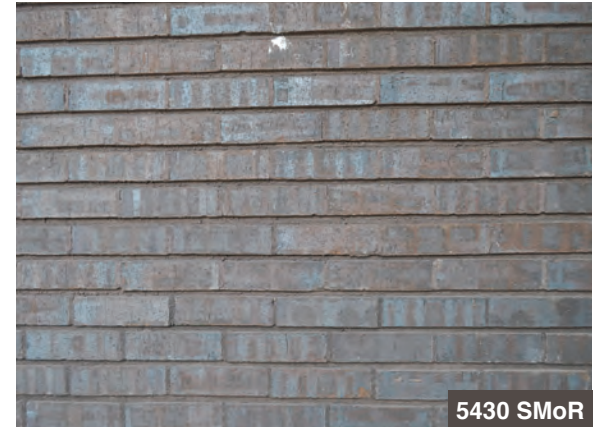
A similar brick is laid with flush vertical joints with no visible mortar, and deeply raked horizontal joints.

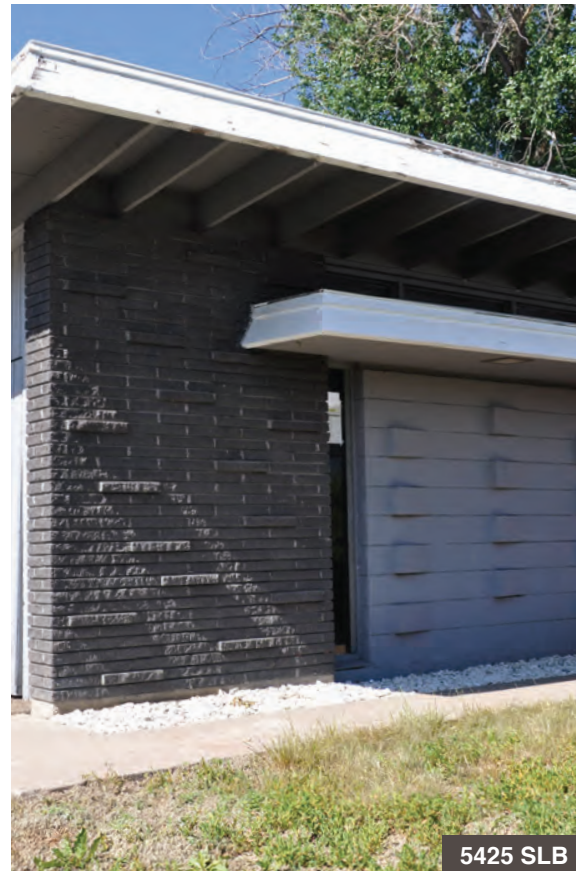
In addition to brick, painted concrete block also commonly appears. It shares many of the same bond and mortar treatments.

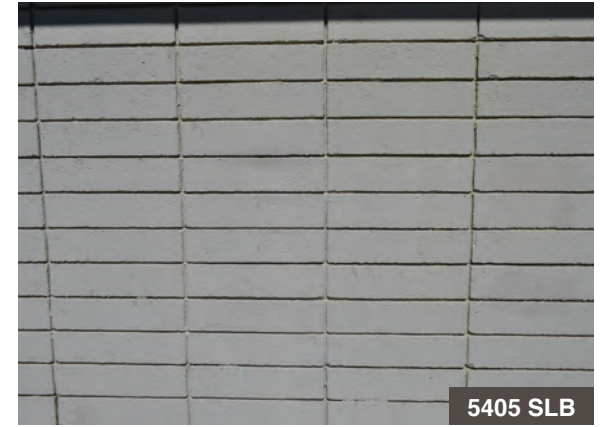
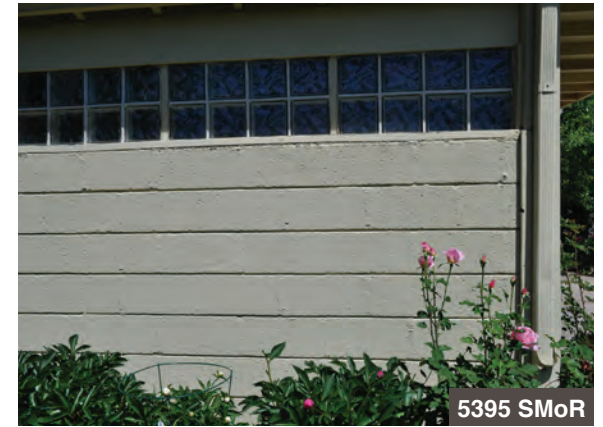
Here, a gray broken-face brick is combined with concrete block. Both feature a pattern of projecting units. Raised bricks project perpendicular to the wall, raised blocks project at an angle. Both cast shadows that vary with the time of day.

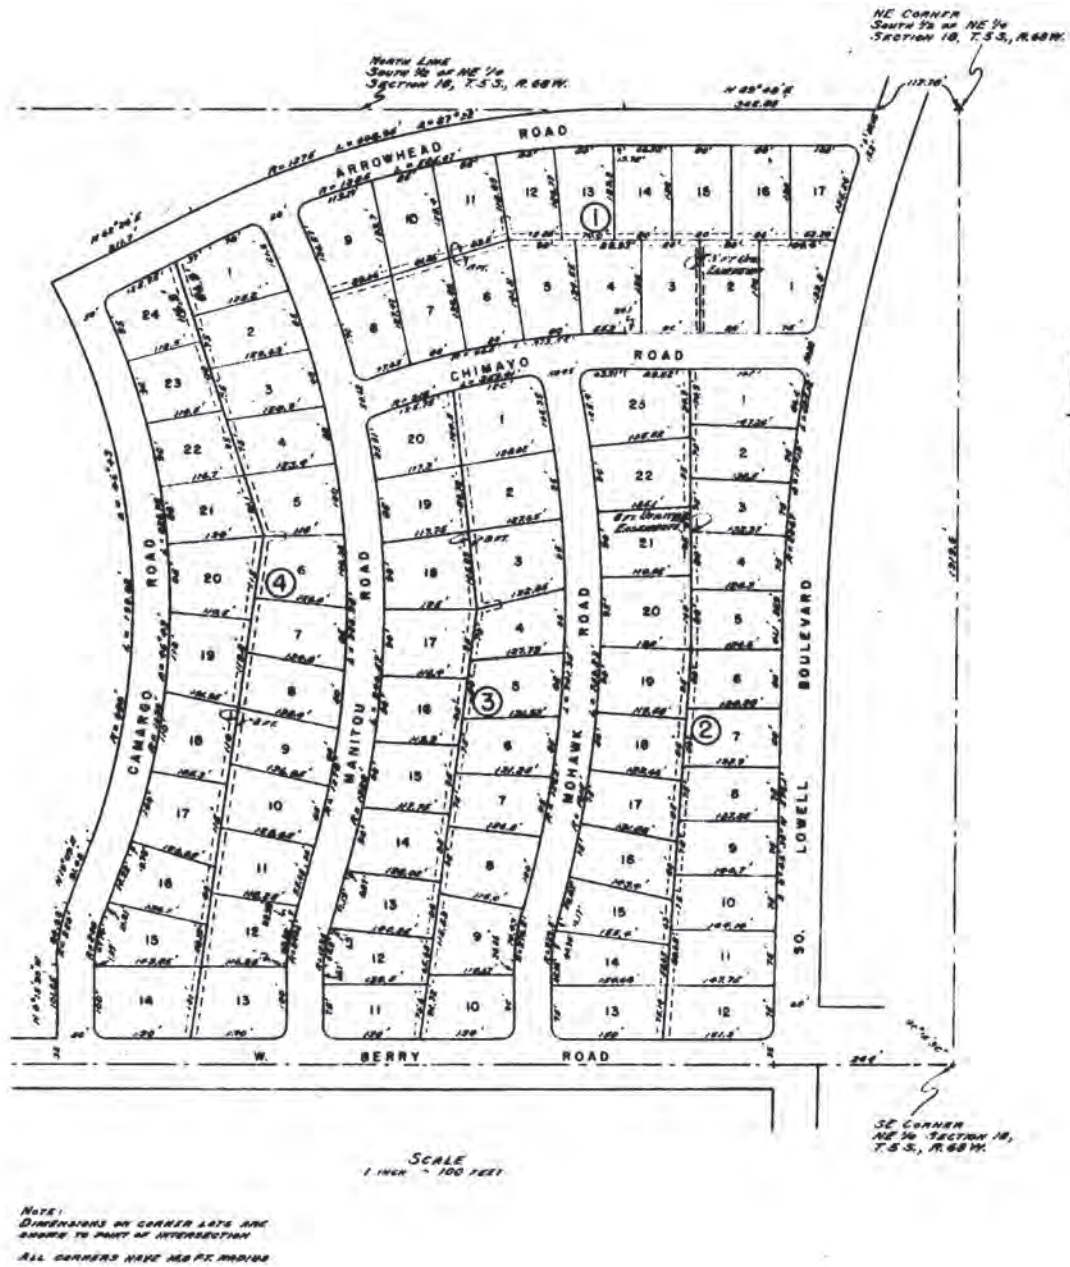
ARAPAHO HILLS SUBDIVISION PLAT
 The original Arapaho Hills Subdivision Plat was filed with Arapahoe County in May, 1955. It included eighty-three planned homes on thirty-seven acres of land.
